NATIONAL ADVISORY COMMITTEE FOR AERONAUTICS

TECHNICAL NOTE

No. 1399

PRELIMINARY INVESTIGATION OF A GAS TURBINE WITH SILLIMANITE CERAMIC ROTOR BLADES

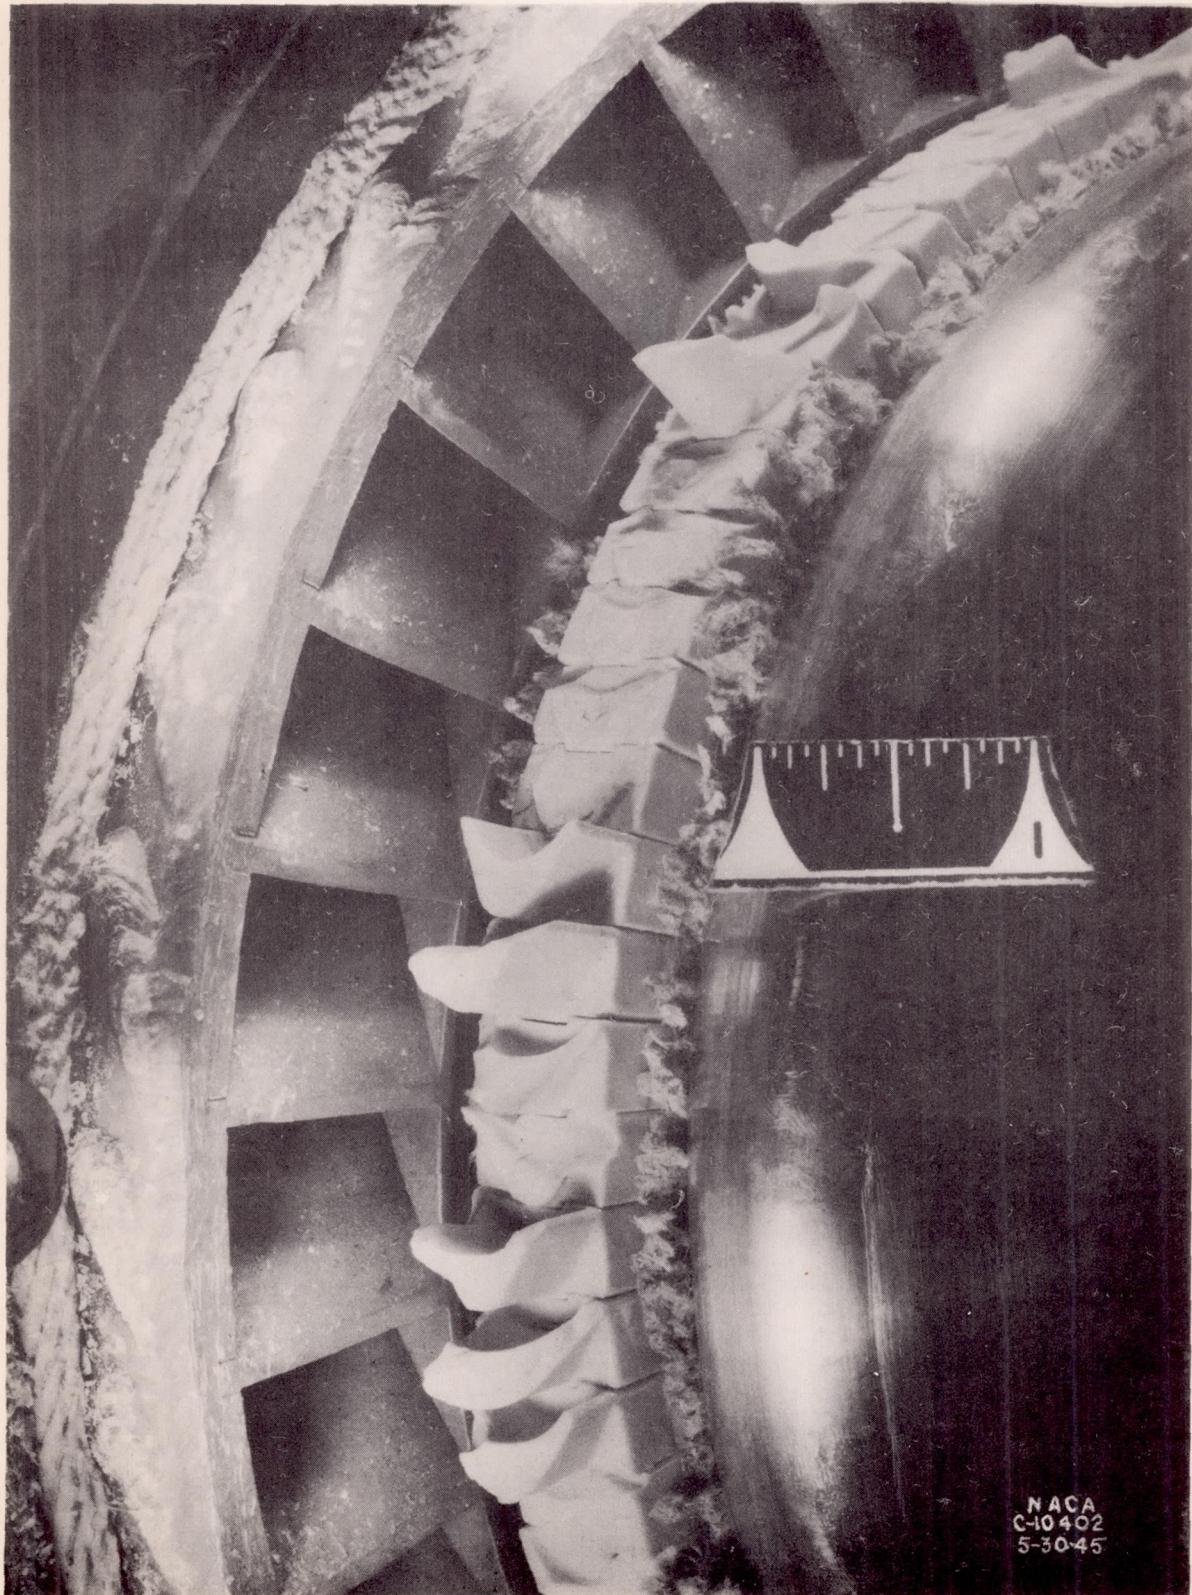
The turbine was initially operated at low rotative speeds and the inlet gas temperature was increased from 200° to 1600° F and then reduced to 500° F over a period of $1\frac{1}{2}$ hours. (See table I.) At an inlet gas temperature of 500° F, the speed was gradually increased to 10,000 rpm at which speed with a total running time of $1\frac{1}{2}$ hours the blades failed. The unit after failure is shown in figure 6.

The setup and the turbine were carefully examined to determine the cause of failure but no positive reason could be found other than the effect of stress concentrations at the $1/32$ -inch-radius fillet between the aerodynamic part of the blade and its base. Most of the blades failed at this fillet with what appears to be a simple tension break. (See fig. 6.) The blades broken above this point were probably fractured by flying fragments after the rupture of the first blade, or blades, at the root.

Figure 6. - Failure of first-design blades after $1\frac{1}{2}$ hours total running time.

The second-design blades differed from the first because of the necessity for reducing stress concentrations in the blade. The blade base was increased in thickness perpendicular to the chord to eliminate the tongue and groove in the root section (figs. 1 and 7) and the radius of the fillets at the most critical section, that is, at the bottom of the blade section, was increased from $1/32$ to $1/8$ inch to reduce stress concentrations. The complete wheel had 58 blades. A gasket with a nominal thickness of 0.025 inch was used between the

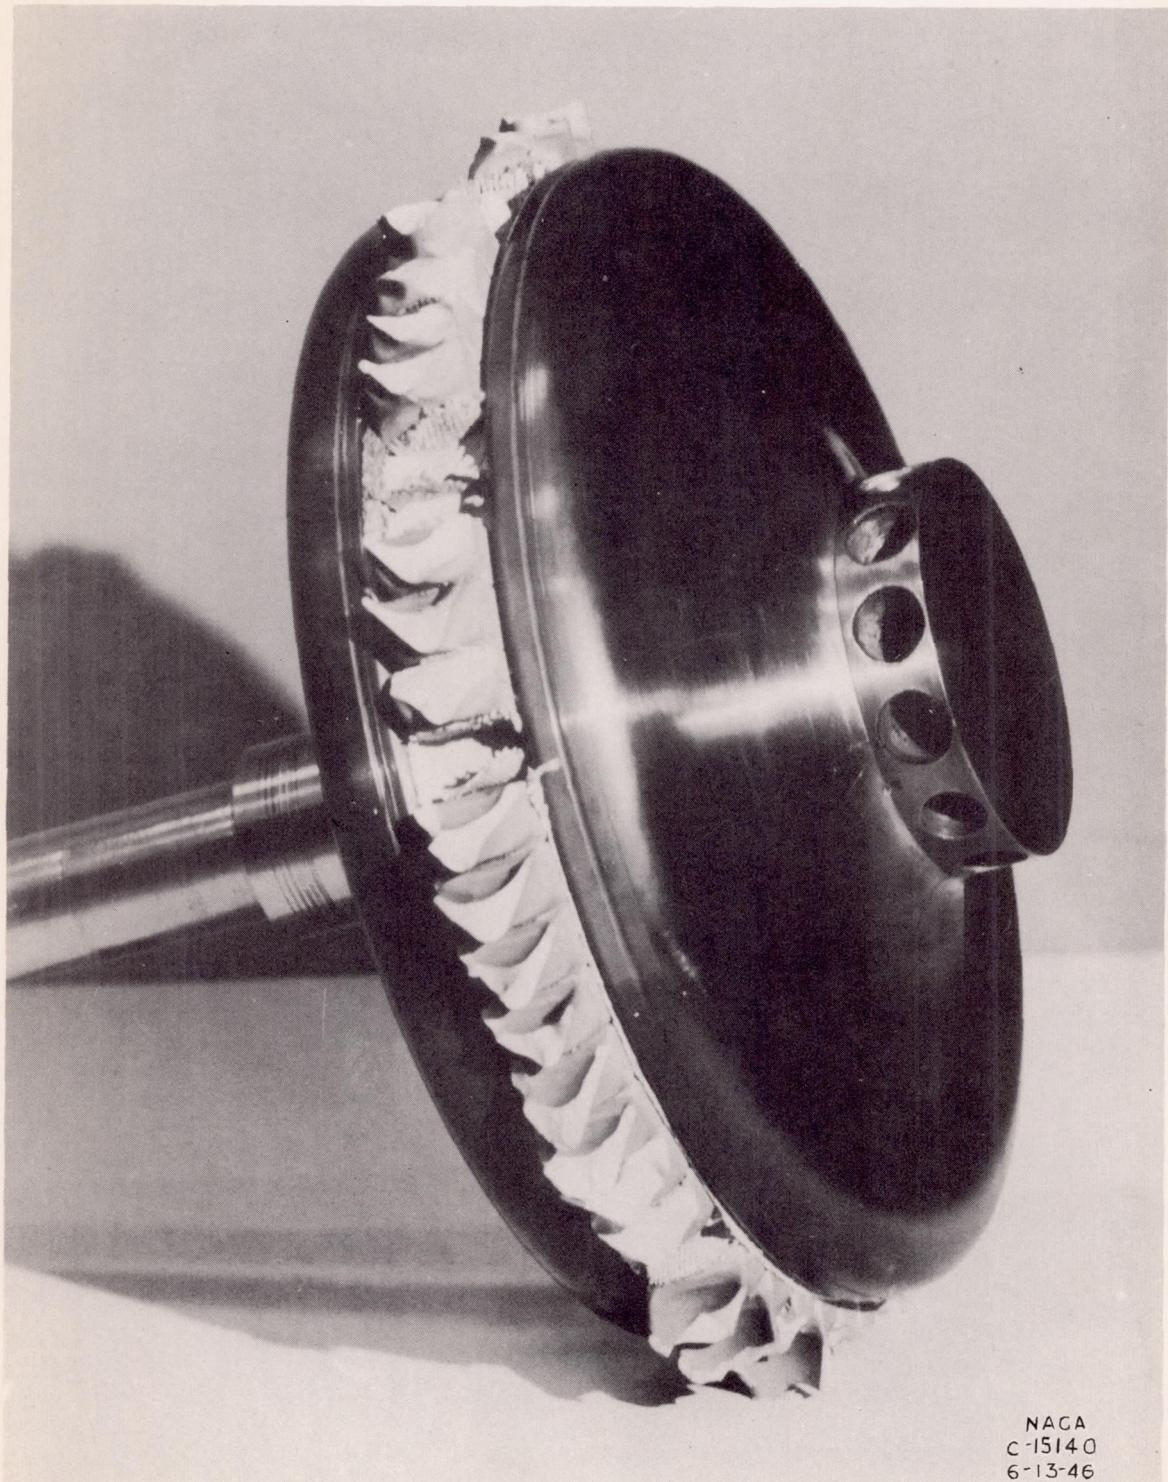
After a total running time of 38 hours (including 5 hr during which the blades were subject to hot-gas flow but the turbine was stationary), a run was to be made at 8500 rpm and 1500° F. The turbine was brought up to a speed of 8100 rpm and a temperature of 1500° F; the speed was gradually advanced to 8700 rpm at which point it fell off to about 6700 rpm owing to an instability in the water brake. The turbine was again brought up to 8300 rpm; after about 5 minutes at this speed, the turbine failed. Figure 11 shows the unit after the failure. A careful examination showed no mechanical reason for the failure. Several blades failed inside the wheel rather than at the base of the aerodynamic section, as occurred in the failure of the first-design blades.

Because of the blade failures at the supporting shoulders, a more detailed analysis of the stresses in the blade base than had been made during the design, was begun. The calculations of compressive stress on the supporting shoulder showed the existence of stress peaks coinciding with the intersection of the line of failure with the supporting shoulders of the blade. These stress peaks could be eliminated by redesign of the blades or supporting disks. Calculations of the stress distribution on these shoulders due to centrifugal loading were made for blade-shoulder and disk-rim contours

that were parallel before centrifugal loading when known load-deflection characteristics of the gasket material were used and zero axial deflection of the disks was assumed. This calculation resulted in a computed peak compressive stress of 100,000 pounds per square inch at 10,000 rpm. For a computed axial deflection of 0.030 inch for each disk, the peak compressive stress increased at least 185,000 pounds per square inch (based on extrapolated gasket-load compression data) at 10,000 rpm with only a minute change in its location. The possibility of a more accurate analysis of the stresses in a ceramic blade is questionable at this time owing to the many unknown factors affecting the calculations such as the actual axial deflection of the turbine disks and complete physical-property data on ceramics.

The point of failure of a ceramic-blade turbine was shifted from the junction of the blade section and its base by reduction of the stress concentration at this point. The second failure of the blade coincides with a high calculated stress peak in the area of attachment due to the radial movement of the blades and the axial deflection of the disks.

Figure II. - Failure of second-design blades after 38 hours total running time.
